Post by Ron Lilburne on the Official Seawind Owners Club, Facebook group March 21, 2023

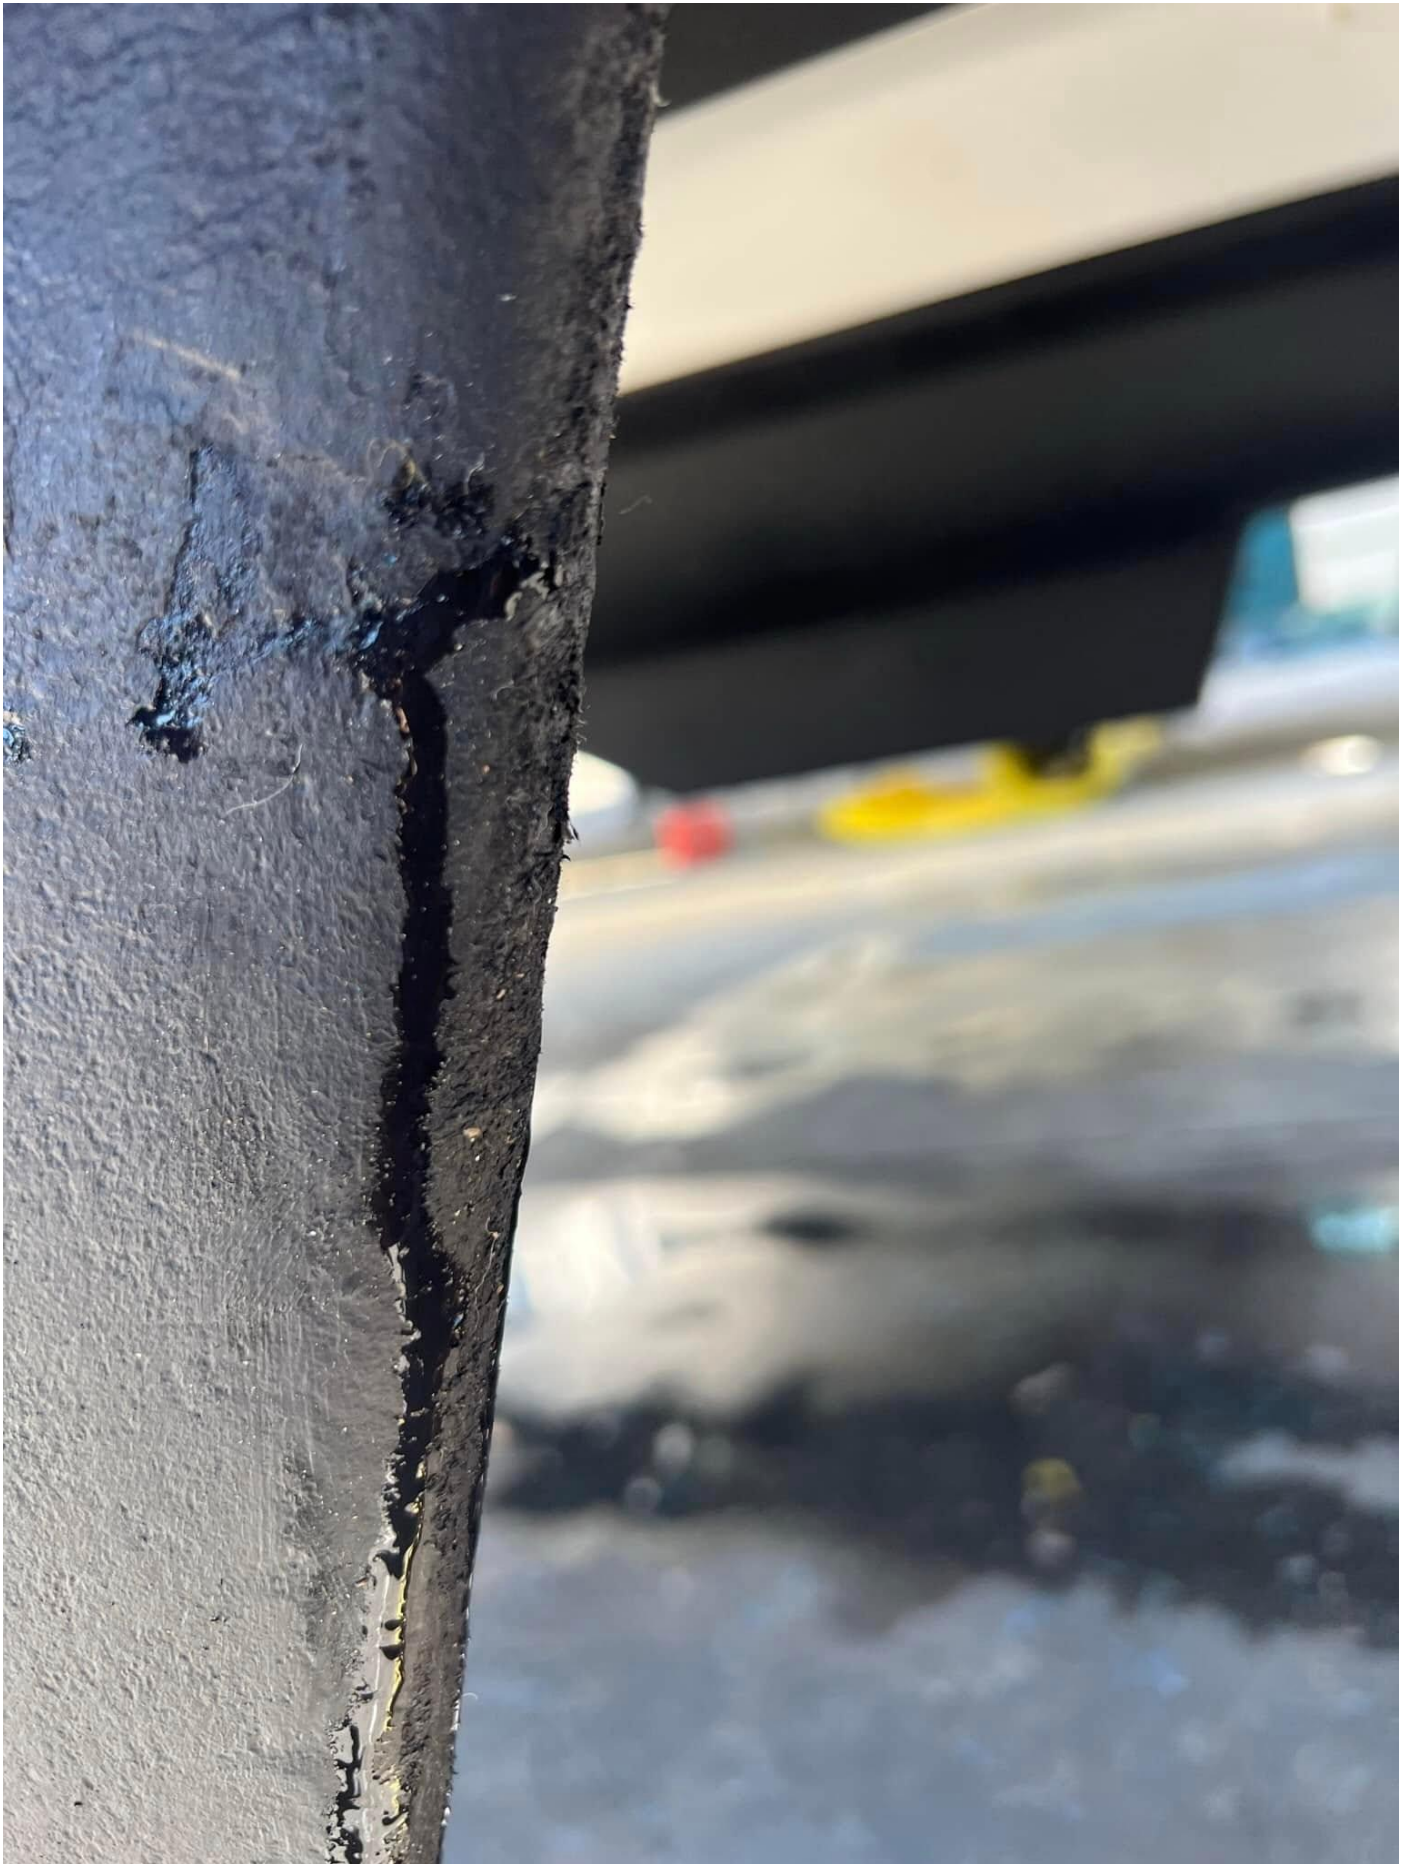
Picture 1

Original weep we repaired then was still present when we lifted boat to return to water.

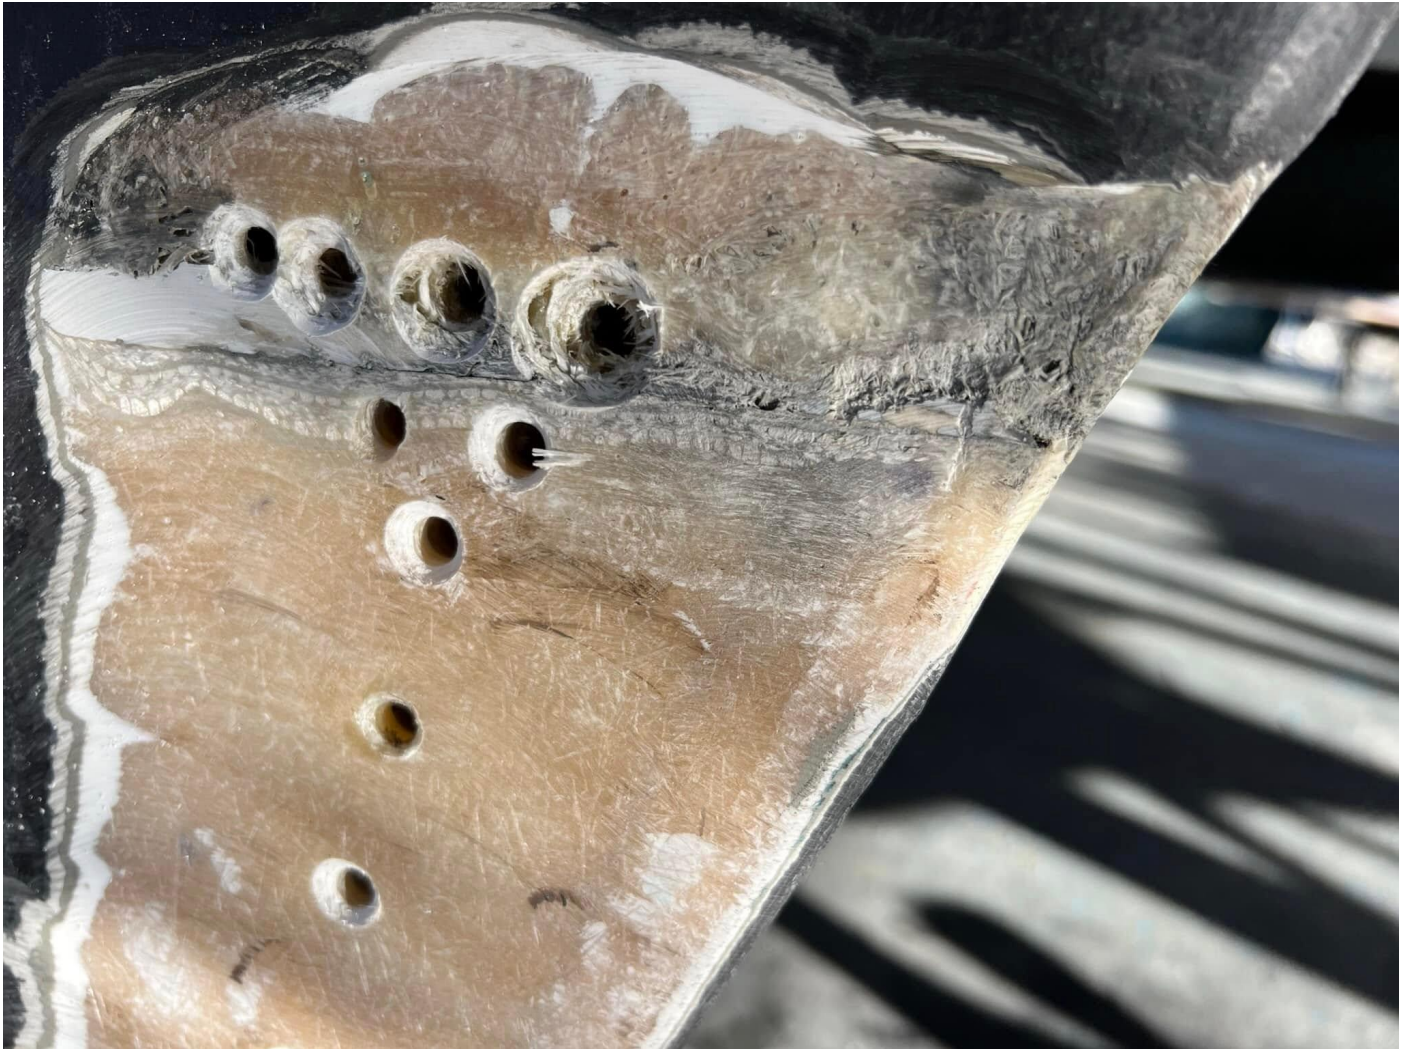
Picture 2

Shows holes we drilled, figuring how deep water was. Turns out keels are hollow, no real issue having water in them except it shouldn't be there. We should have started lower re drilling.

Prepping Swiss cheese effect for filling with epoxy. Notice grey area where keel joins hull, quite pronounced on stern end. Effectively the glass lacks resin in original lay up, annoying but no buggo for a boat this old. Water seeped into keel here.

*Note : large hole near bottom not shown, this is where the water was drained*
