There were numerous difficult bolts to remove when disassembling the rear cover on the SD20 saildrive. The worst were the two M10 bolts holding the rear cover to the saildrive leg.

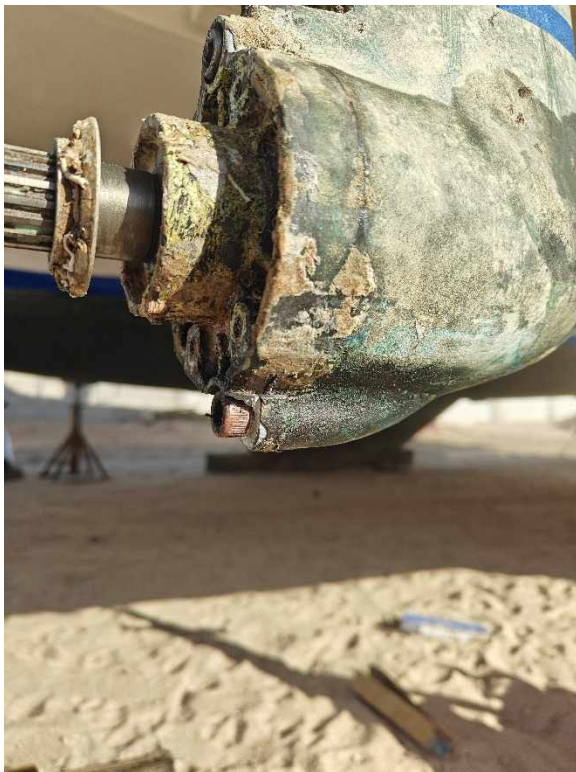
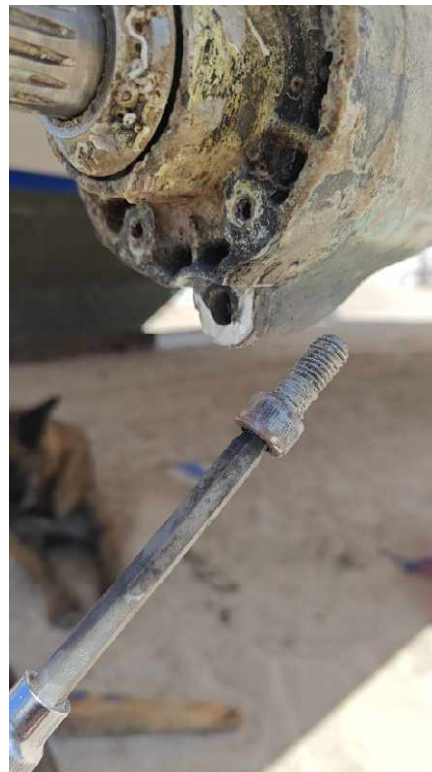
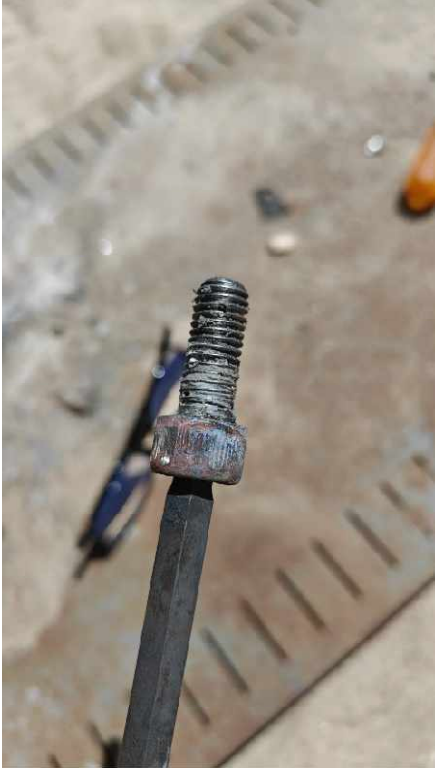
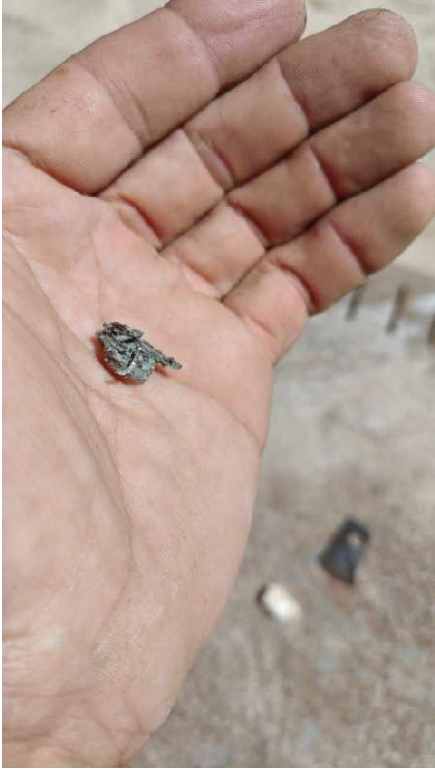
This process ended up taking five hours to remove the last bolt, here is what was tried:

*Note: Each removal was attempted after hammering a ball end Allen wrench in the bolt for 1 minute, then 30 second with an impact drill*

1. Use a pick, small screwdriver, and a piece of safety wire in a drill to remove marine build up between the housing and the bolt (1 hour)
2. WD-40 spray, wait 30 minutes, attempt removal
3. Vinegar, wait 30 minutes, attempt removal
4. Penetrating oil, wait 30 minutes, attempt removal
5. Repeated steps 2-4
6. Fill plastic container with Barnacle buster and soak for two hours, attempt removal
7. Soaked overnight in penetrating oil, applied head with a blow torch to the head of the bolt, cool with ice, attempt removal
8. A piece of safety wire in a drill to clear debris
9. Cut off flange of rear cover on saildrive
10. Bolt came free
