Post by Mark Hardesty on the Official Seawind Owners Club, Facebook group June 30, 2019

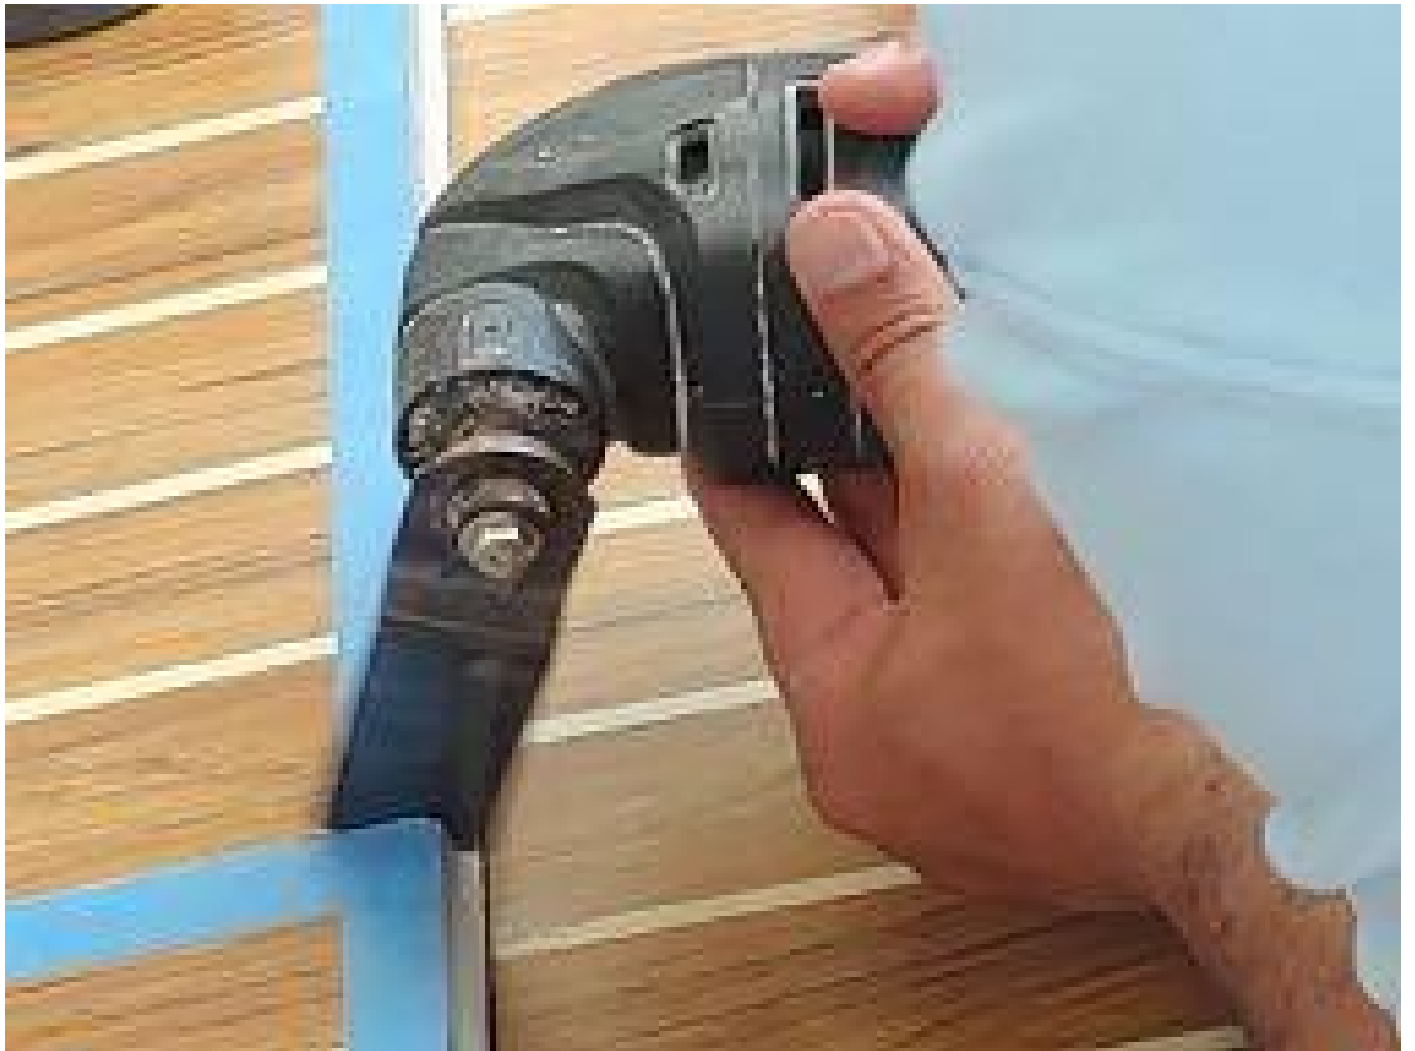
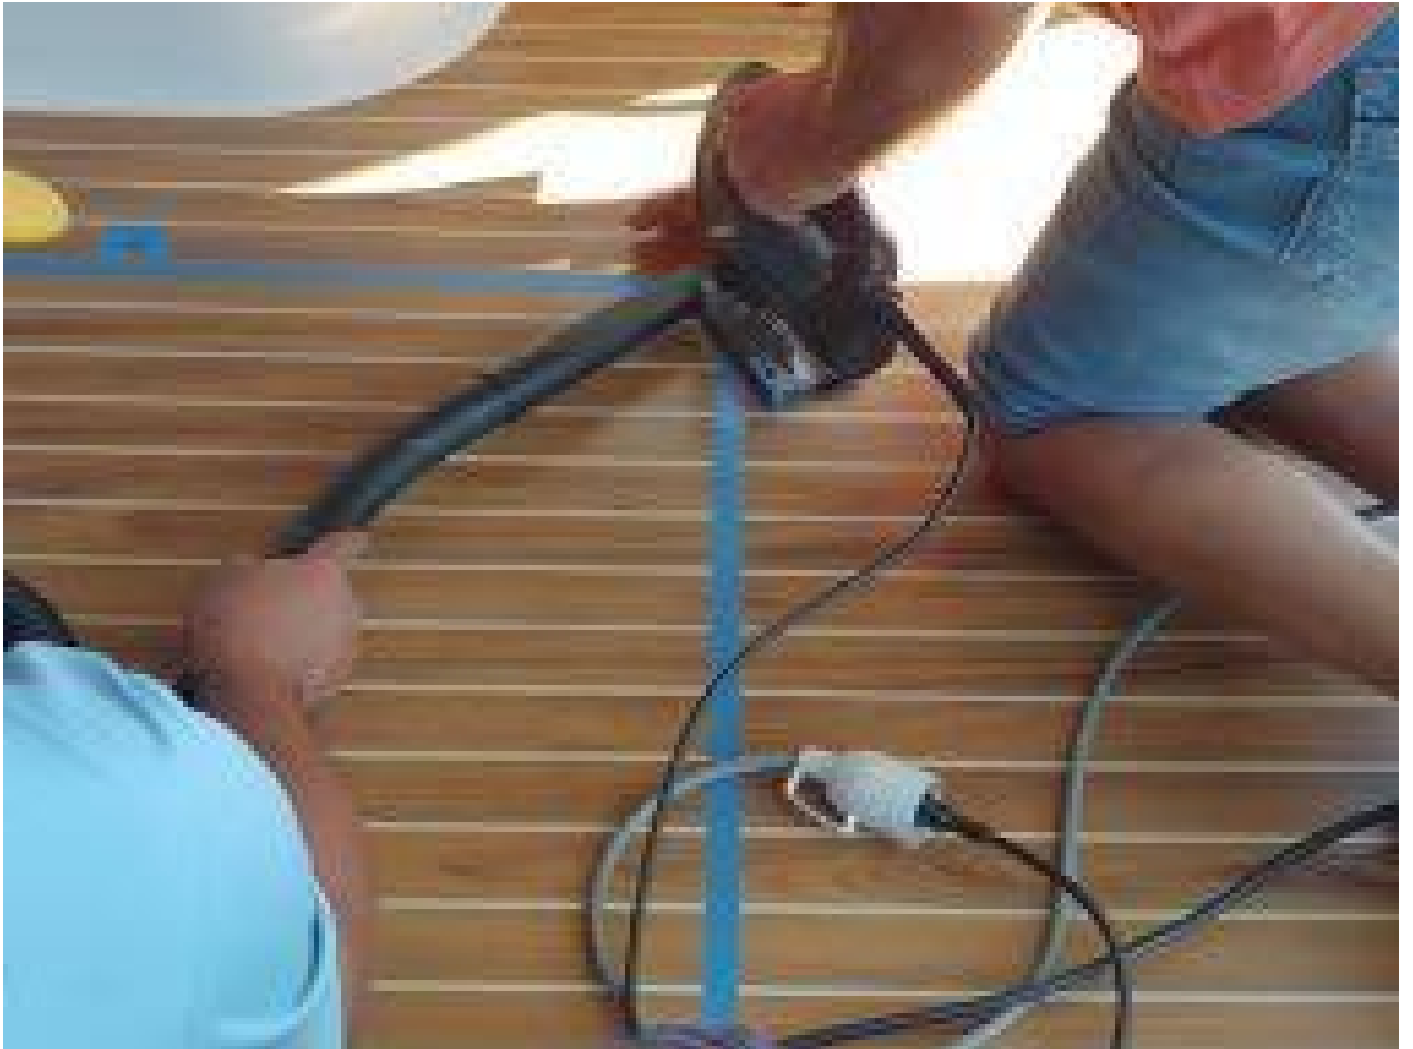
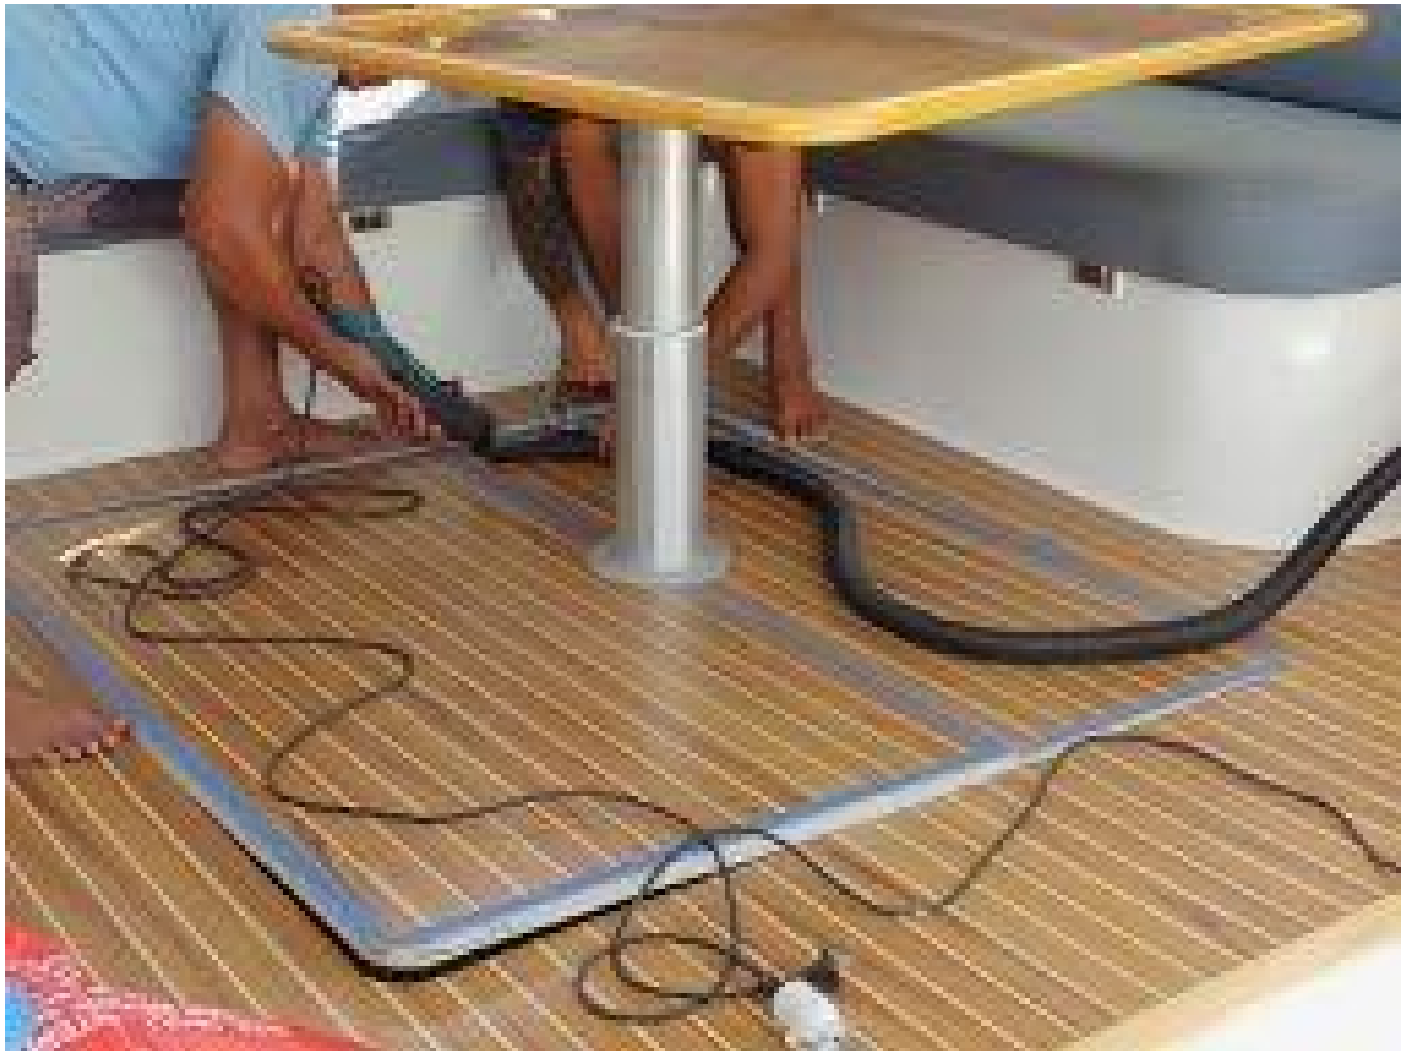
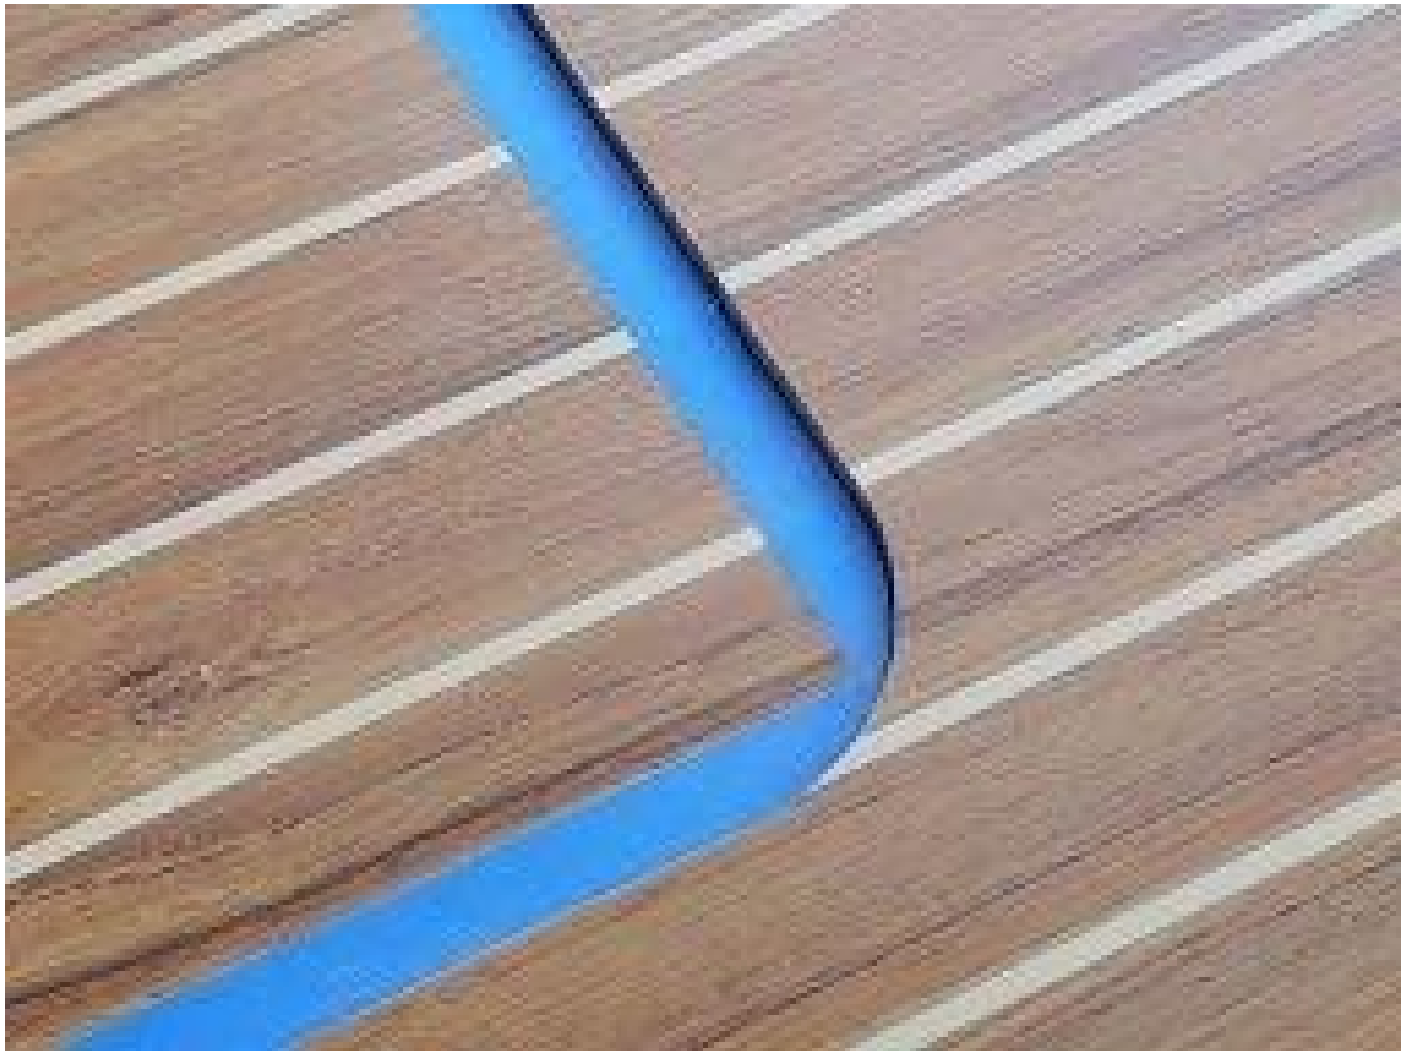
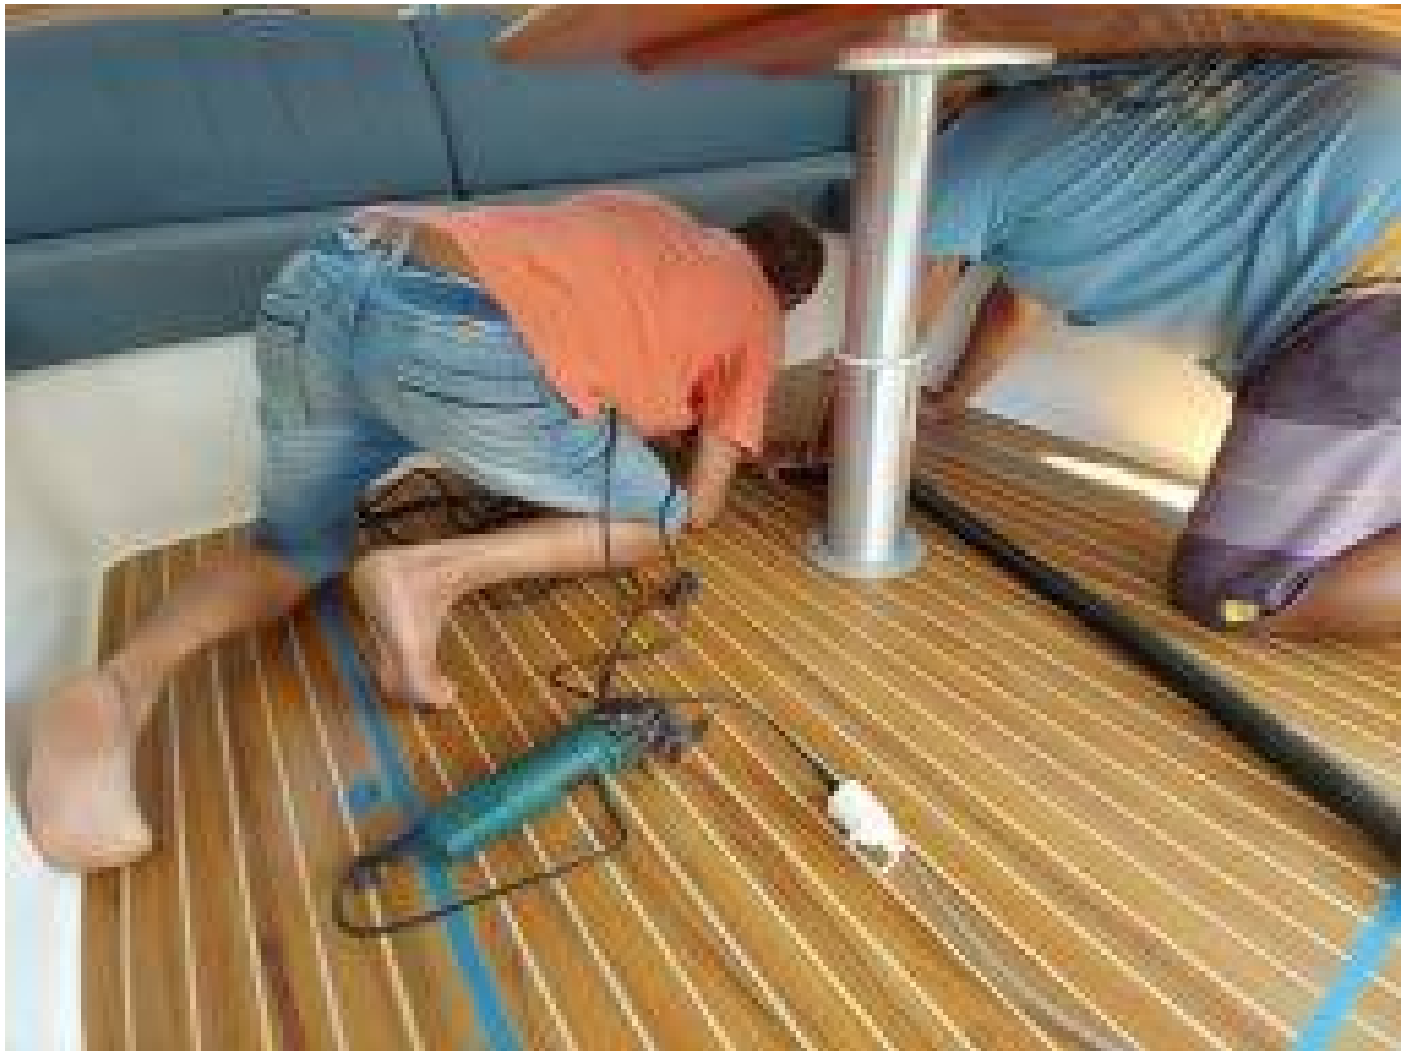
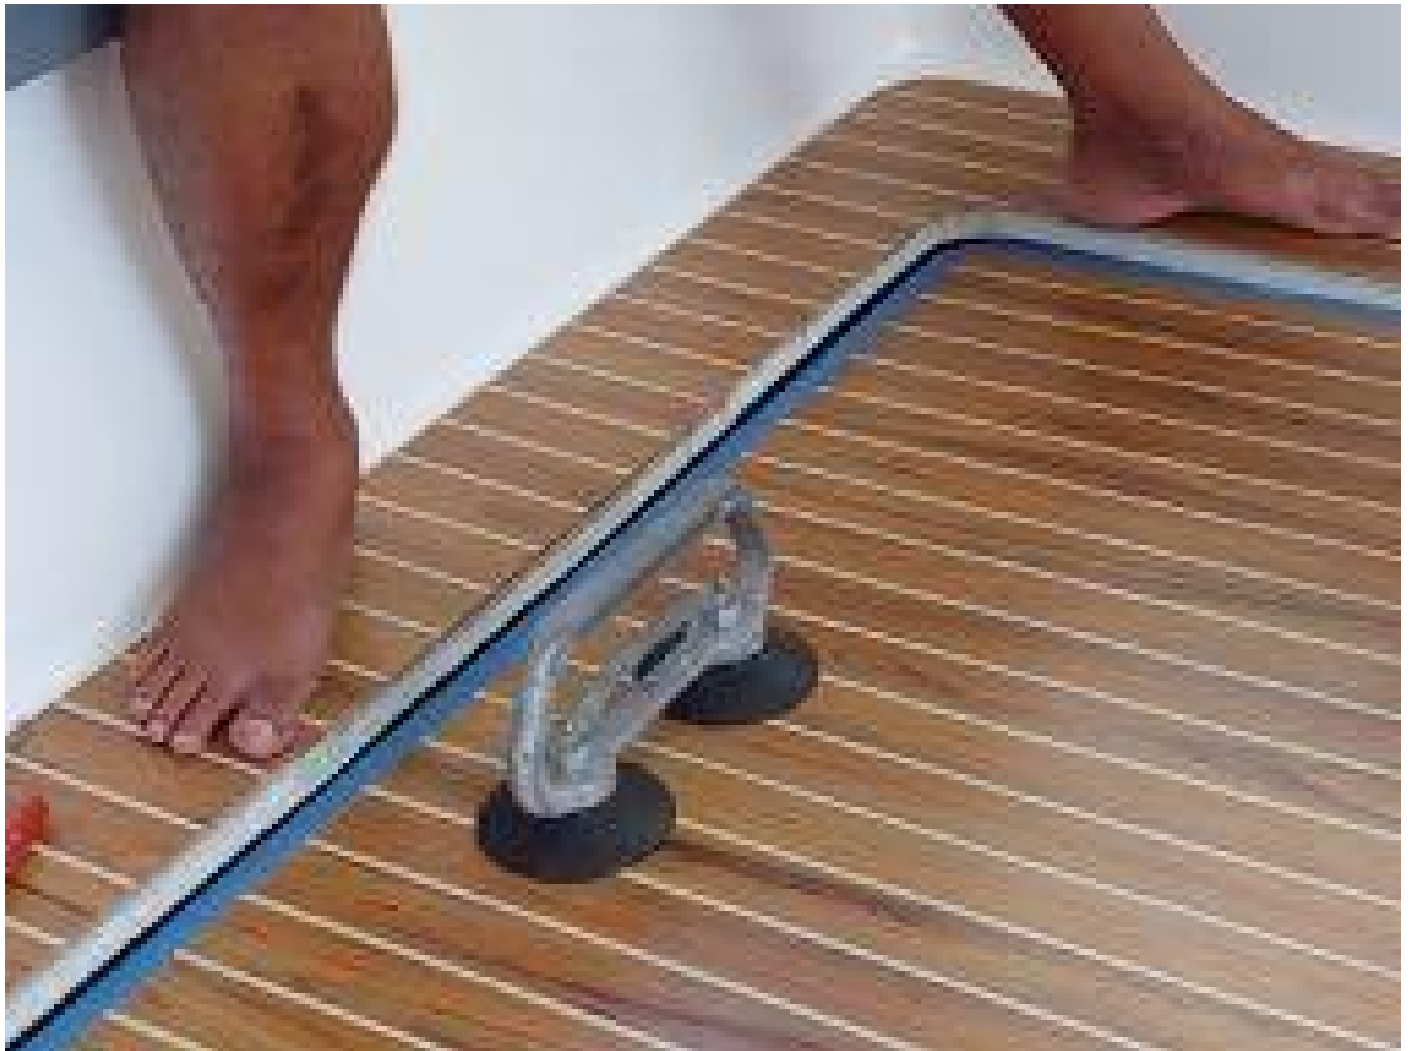
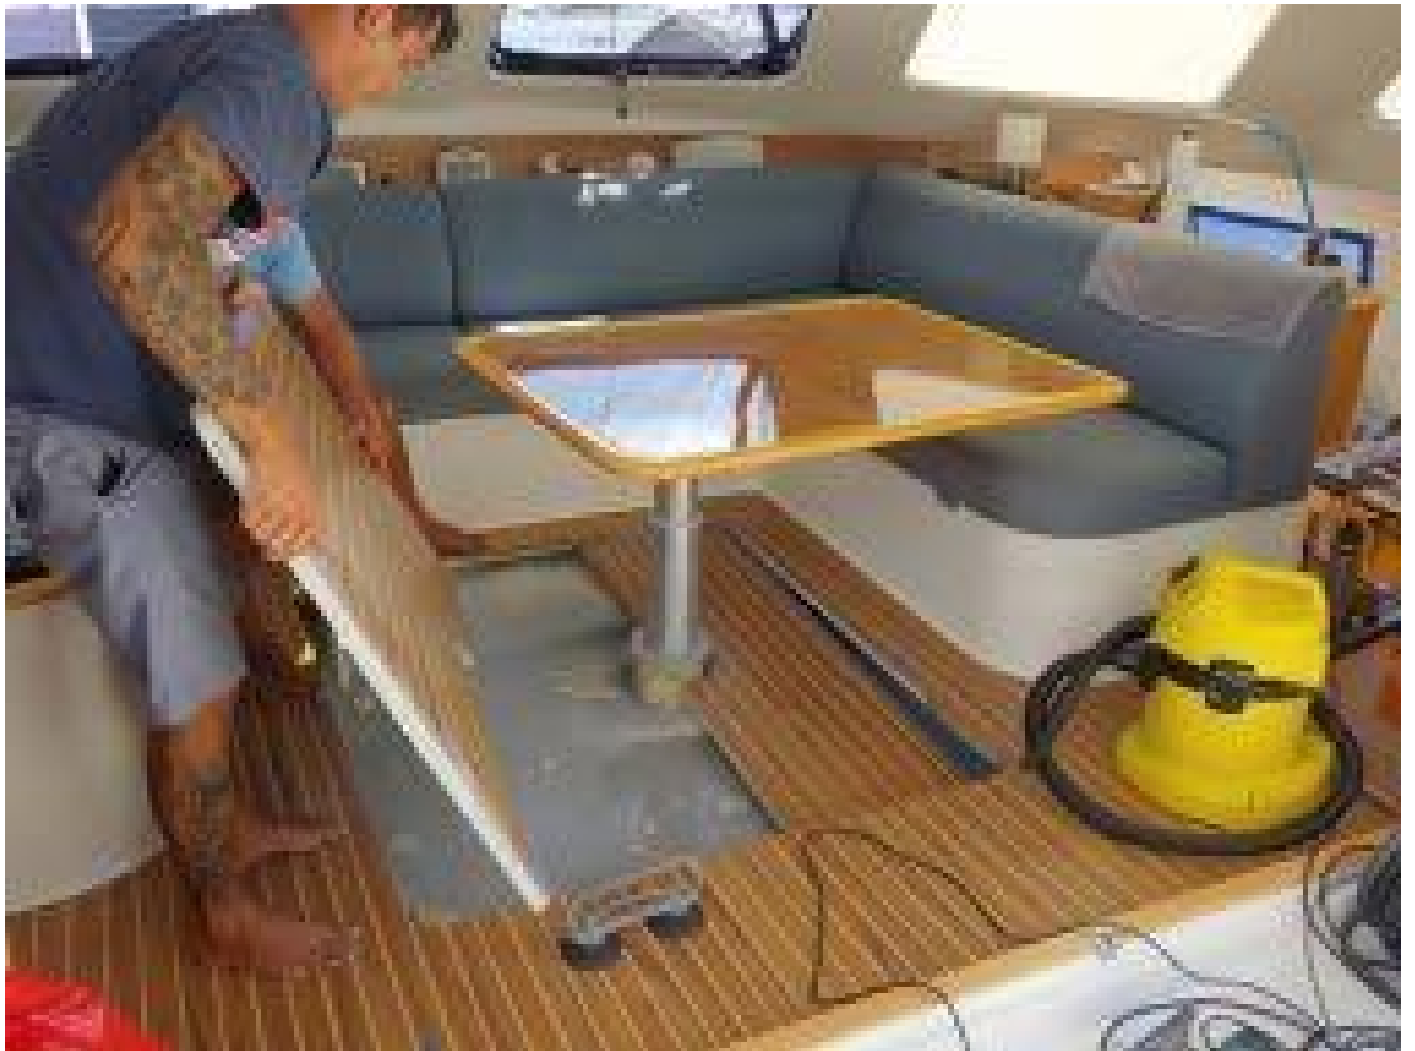
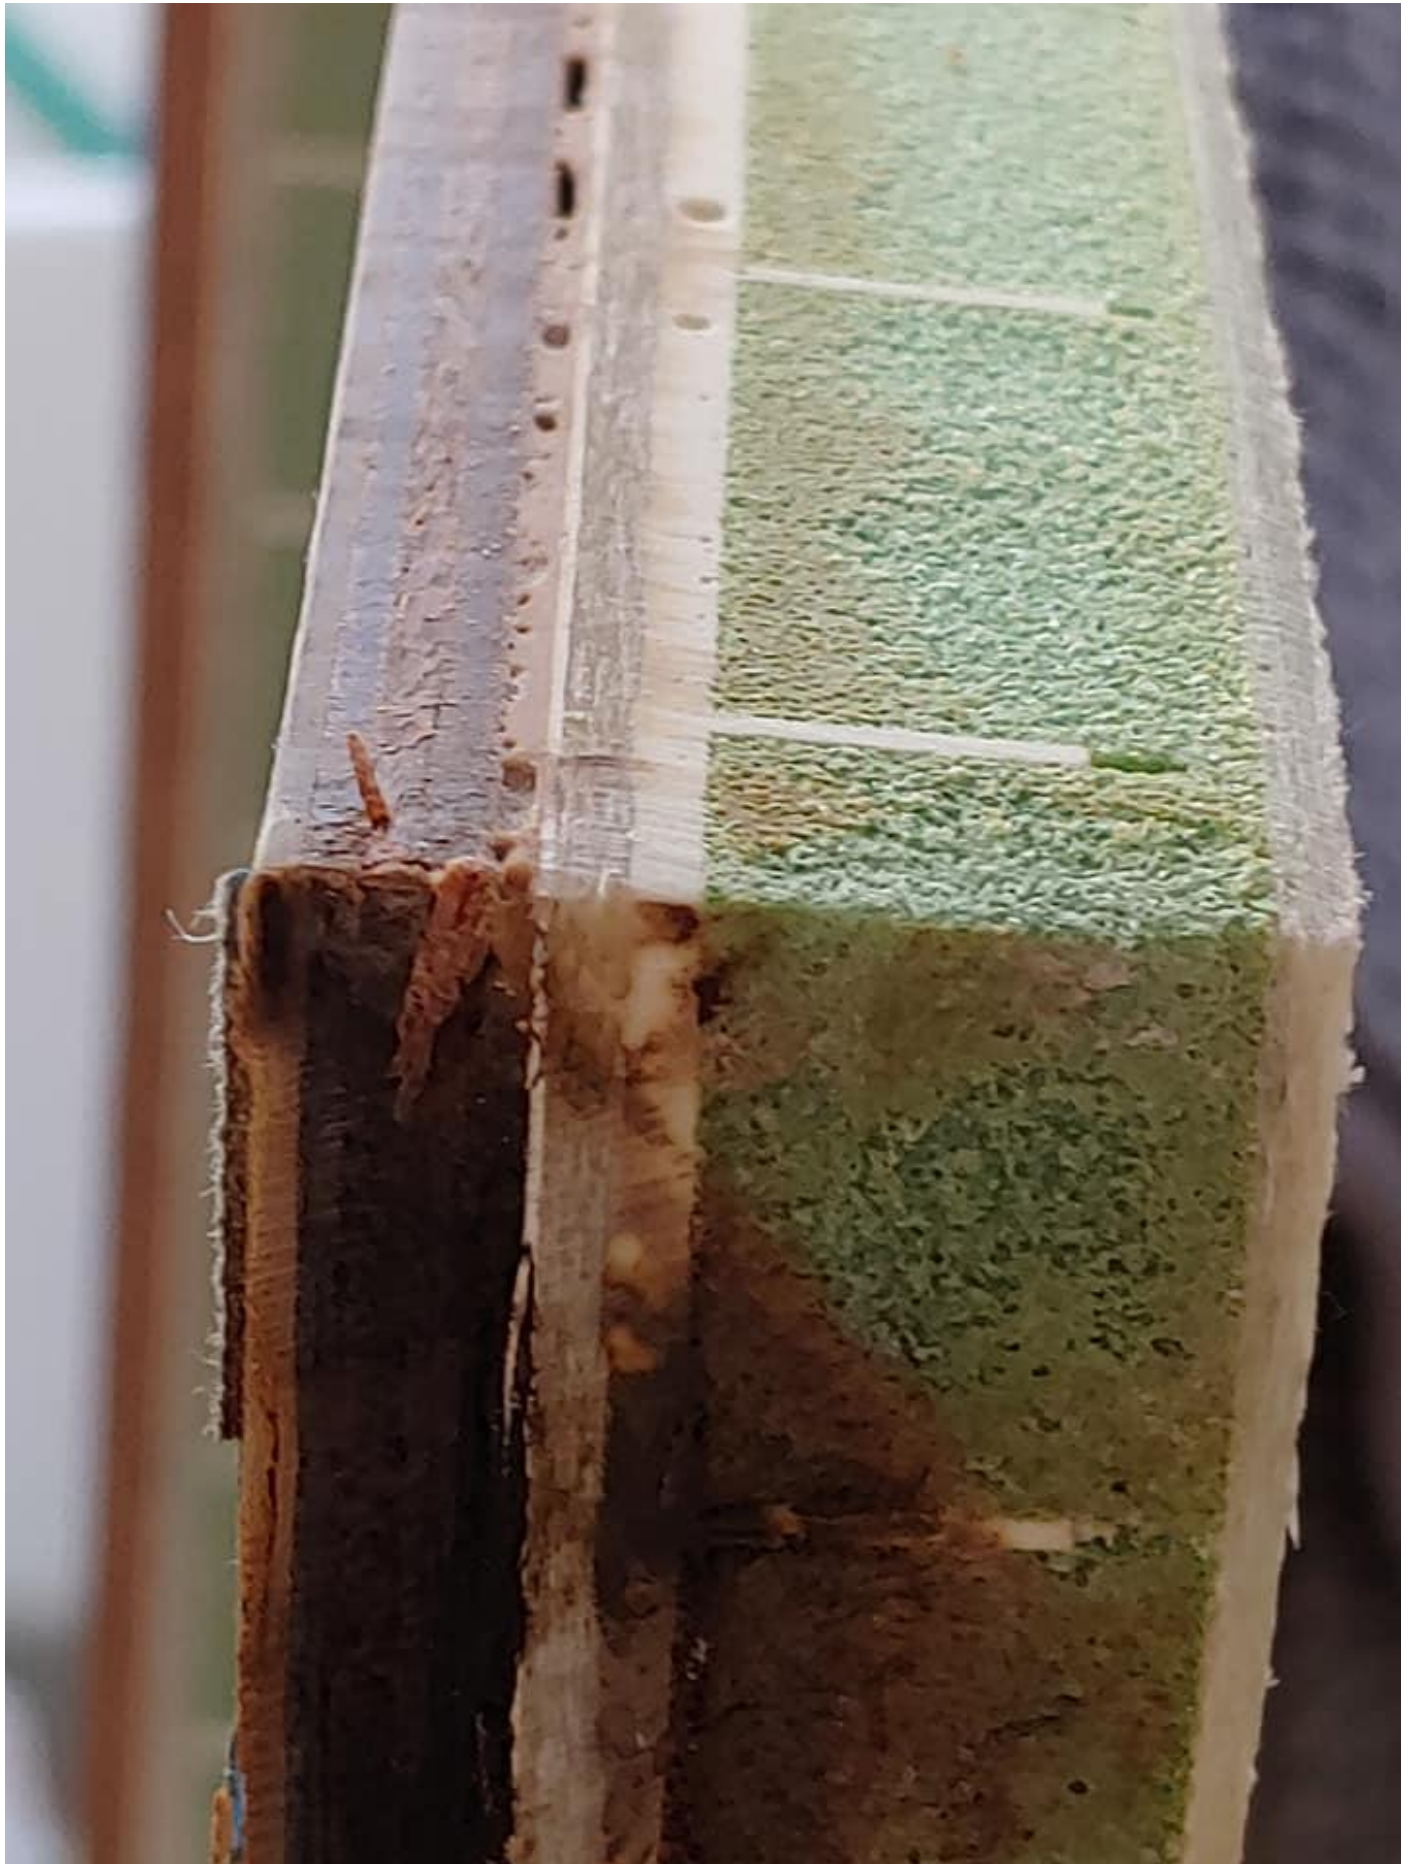
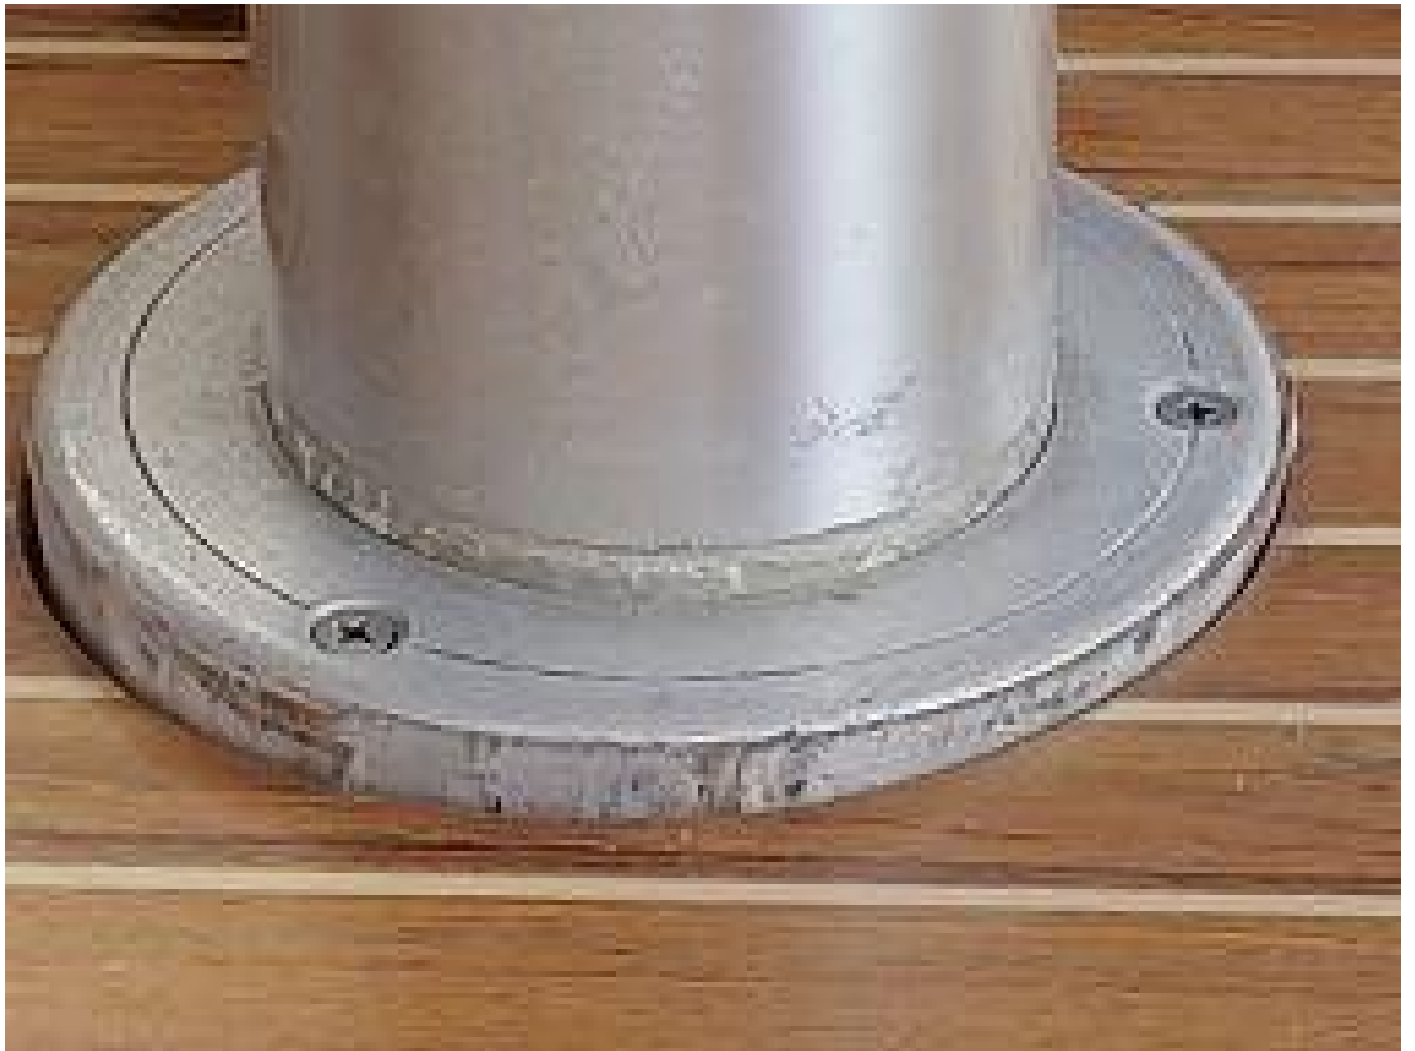
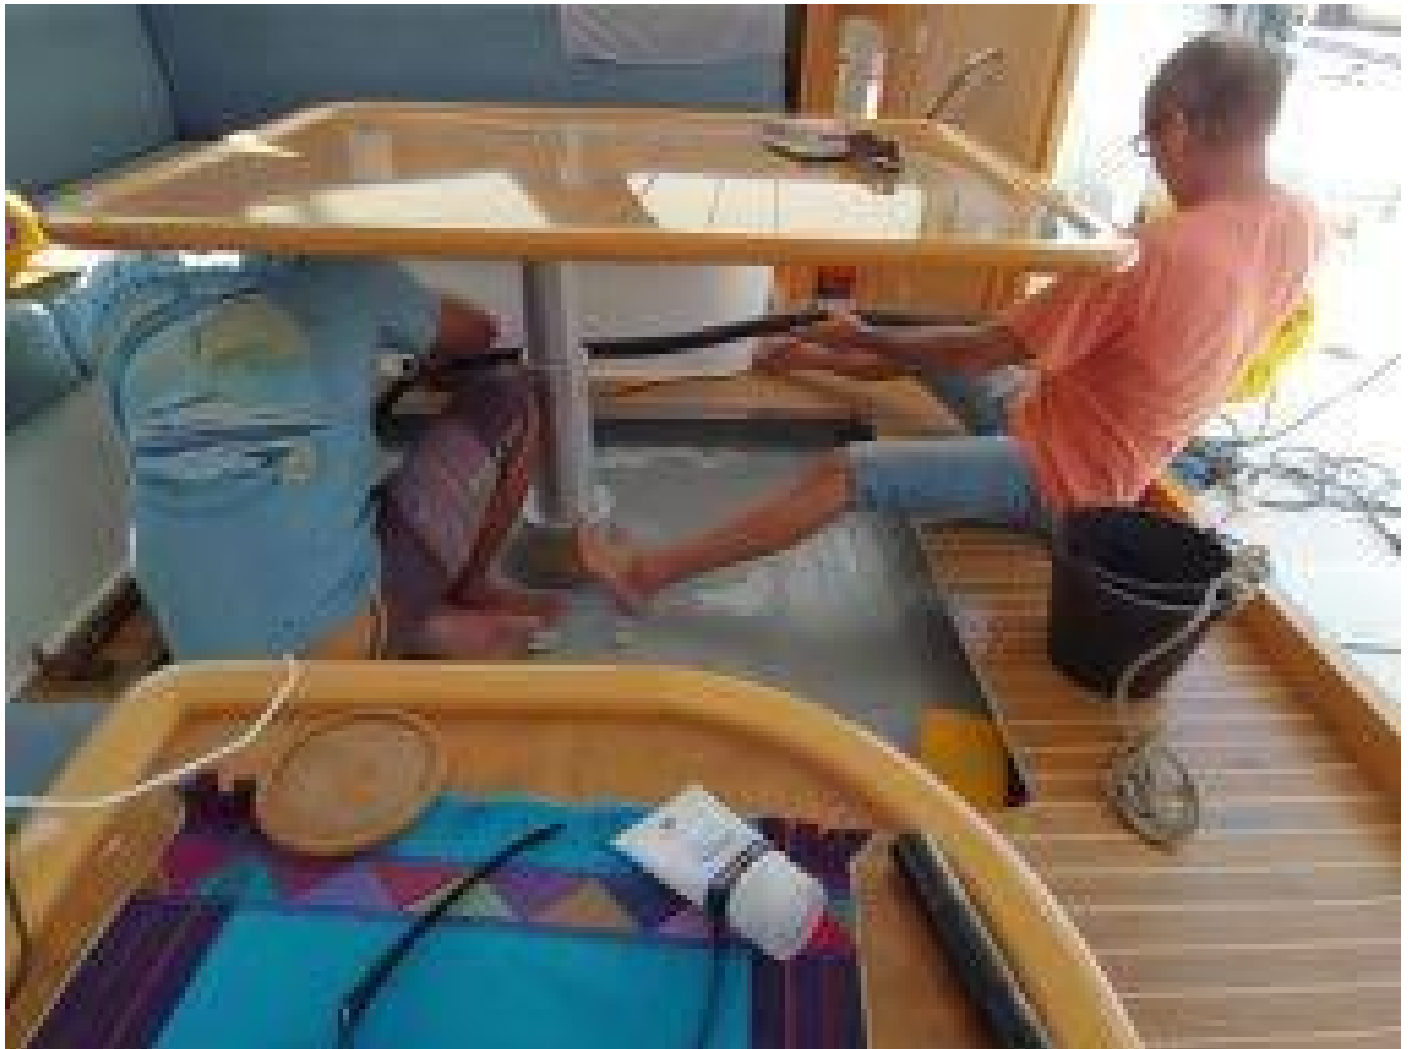
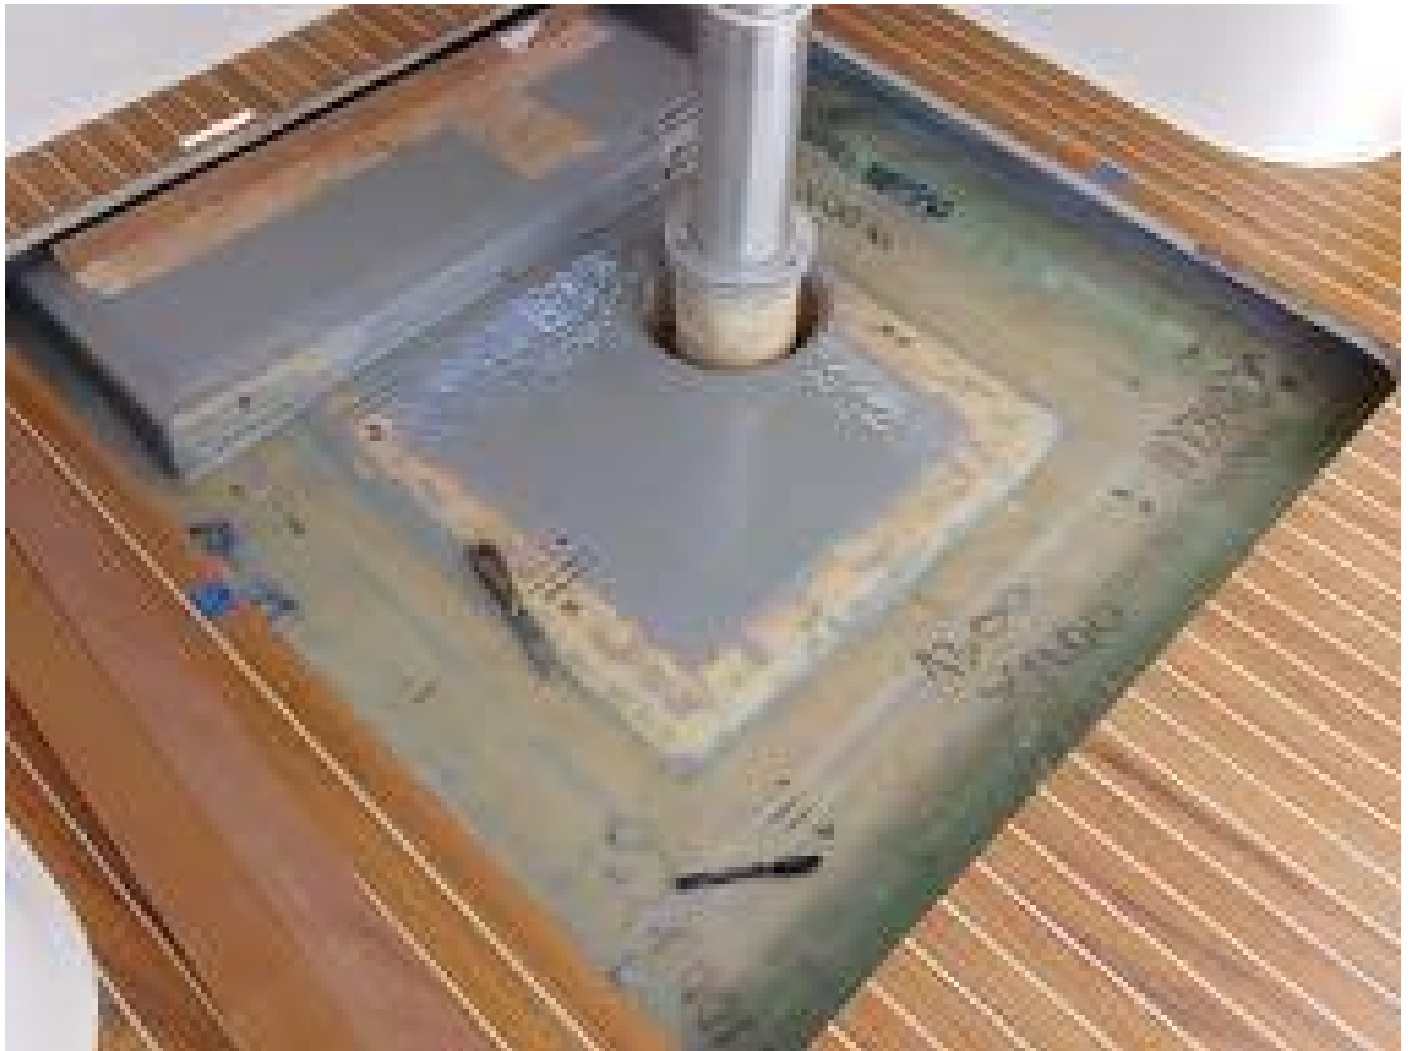
Demolition began and completed today. Floor cut with 1mm blades to minimize repair line. Tank filled with water, first leak spotted at about 350 liters, at around 600 liters a second location at the same level simply went off like a fountain. Seriously weak structure. Will begin repair process tomorrow; with luck will be done by COB Wednesday. Taking pix and will post soon. Expensive bugger to attack.

Note: In the photos - the cut open tank is NOT from Jolly Dogs, that photo was posted by Talisker Seawind

JollyDogs is proceeding with the factory repair procedure, modified by the method the saloon floor was cut and ultimately reinstalled. Structural work on the tank is per or superior to the factory method, and extra stringers / ribs installed to accommodate the floor cutout required to deal with an uncooperative table. We never got the table loose, and had to cut a ring all way around the trim ring at the base of the table, as even that seemed bonded in.
