OPERATING PROCEDURE for "LEAKING WATER TANK"

Repair Procedure

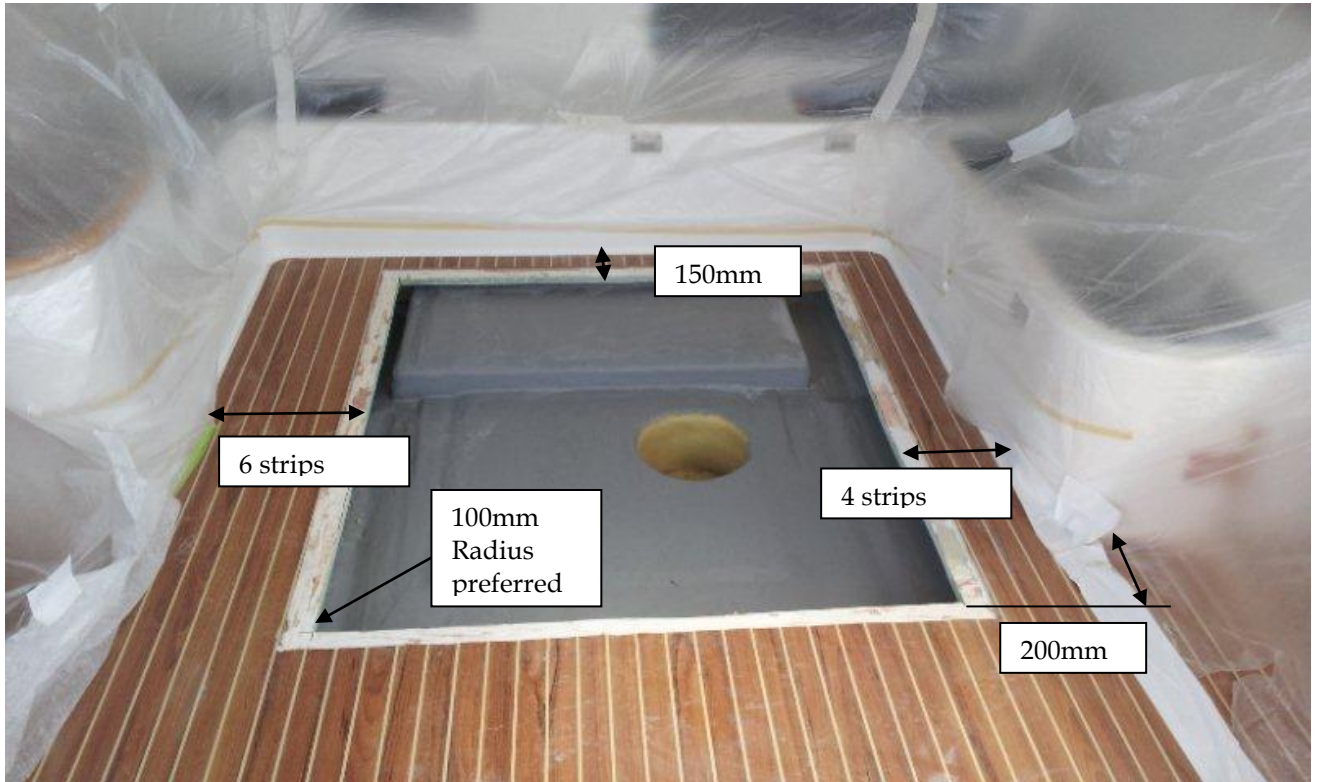
1. Cut flooring around approximate shape of water tank to allow for easy access – preference for cut in deck is for 100mm radius corners, not square as Figure 1 shows. NOTE cut out similar to table size

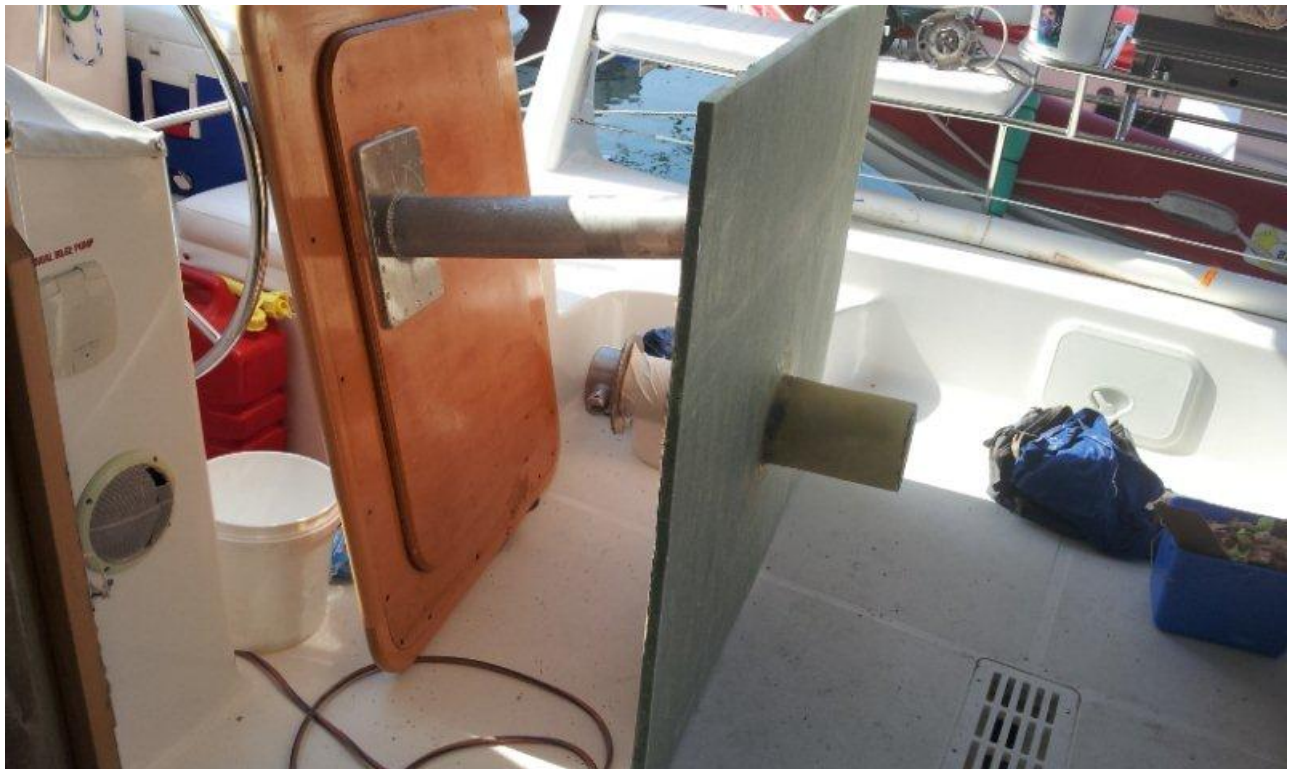
Figure 2 - cut out similar in size to table

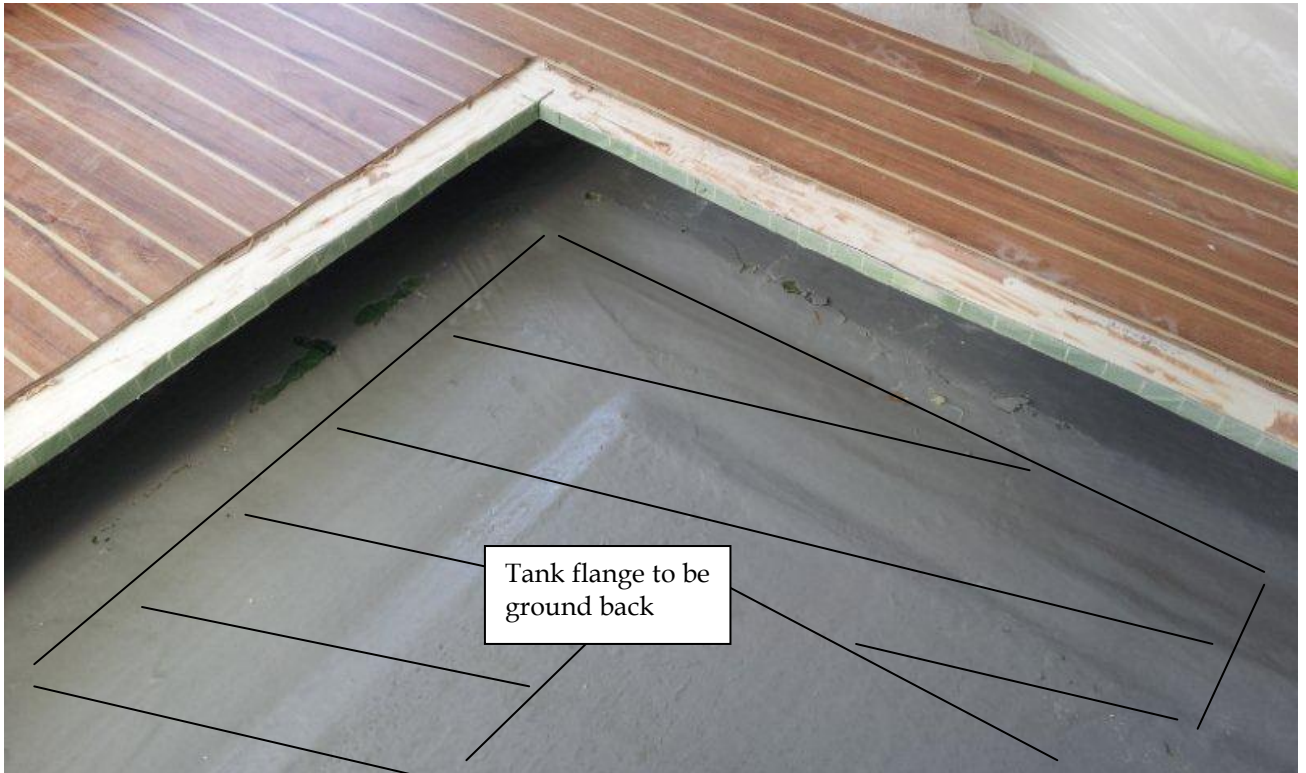
Figure 3 - tank flange

3. Empty tank and grind back the entire tank flange glassing to allow for a good bond – refer to figure 3
4. Re glass tank flange using vinylester resin (ensure glass is resin rich) – refer to hatching on figure 4 & 5

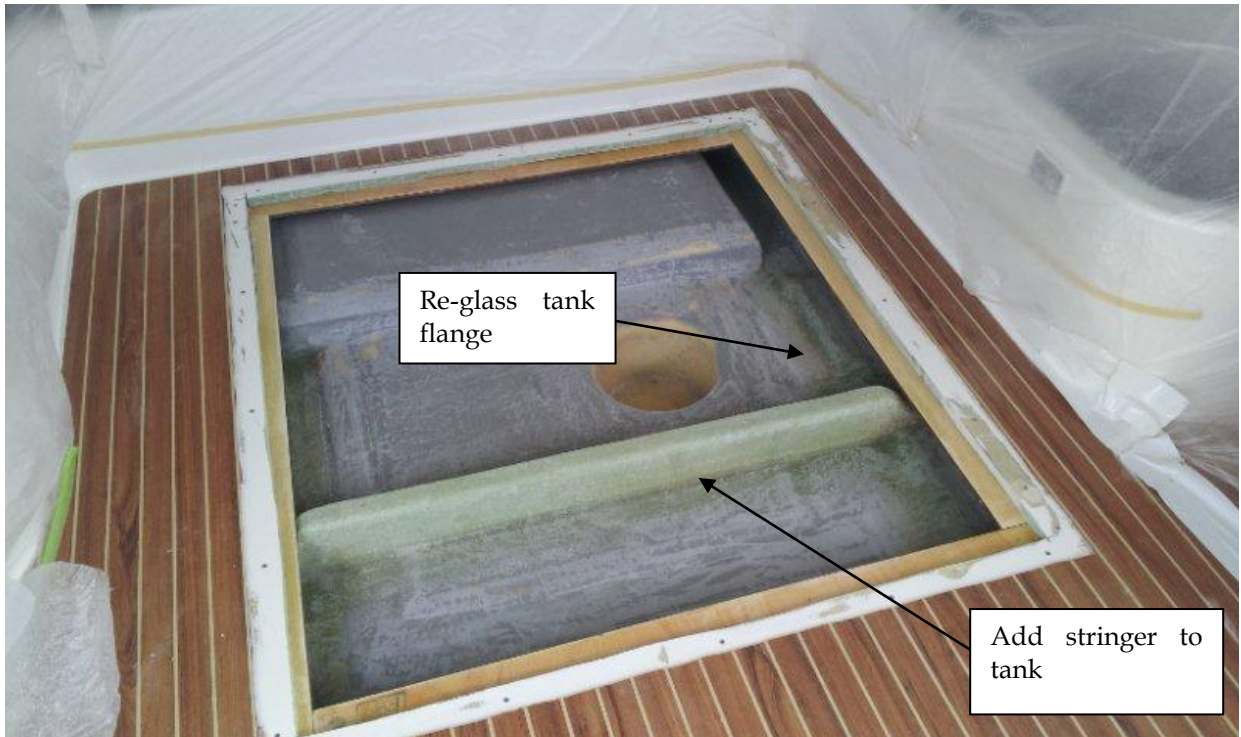
Figure 4- re-glass tank flange & add stringer

5. Glass on a foam or timber stringer over the tank to reduce the amount of flex when the tank is overfilled (this will help prevent the problem re occurring)) – refer to hatching on figure 4 , 5 & 6
